TECHNICAL NOTE

1525 (P-401)

U.S. DEPARTMENT OF THE INTERIOR Bureau of Land Management

FORD

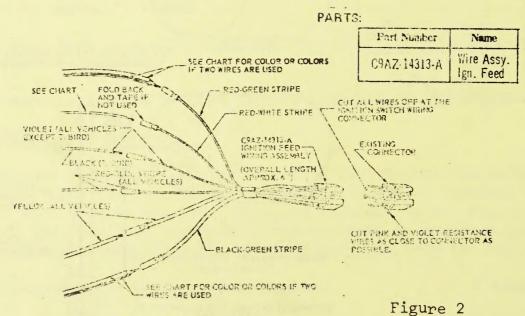
4. ELECTRICAL MALFUNCTION - ENGINE WILL NOT START, ELECTRICAL COMPONENTS INOPERATIVE (Addition to TSB-1704--all car lines, light and medium trucks, 1968-69)

Inoperative electrical components can be caused by a loose electrical connection at the ignition switch. This loose connection may result in damage to the switch and wiring connector. The wiring connector should be replaced, as outlined below, on units that exhibit connector damage.

- A. Disconnect battery.
- B. Remove ignition switch and disconnect existing connector.
- C. Cut the wires at the ignition switch and discard the connector. Refer to Figure 2.

NOTE: The pink and violet resistance wires should be cut as close to the connector as possible.

- D. Strip 5/16 inch off insulation from the main wiring end of the cut wires.
- E. Refer to Figures 2 and 3 to determine proper color match for the appropriate vehicle line and securely crimp the wire into the proper butt connector of the new ignition feed wire assembly.
- F. Install new connector to ignition switch using care not to cock the connector during installation (cocking the connector may spread the new terminals).
- G. Install ignition switch, connect battery, and check for proper operation of switch.
